OSAGE - GASCONADE BASIN

D & R PIPELINE CONSTRUCTION COMPANY LAKE
GREENE COUNTY, MISSOURI
MO 20396

PHASE 1 INSPECTION REPORT

(b) NATIONAL DAM SAFETY INSPECTION

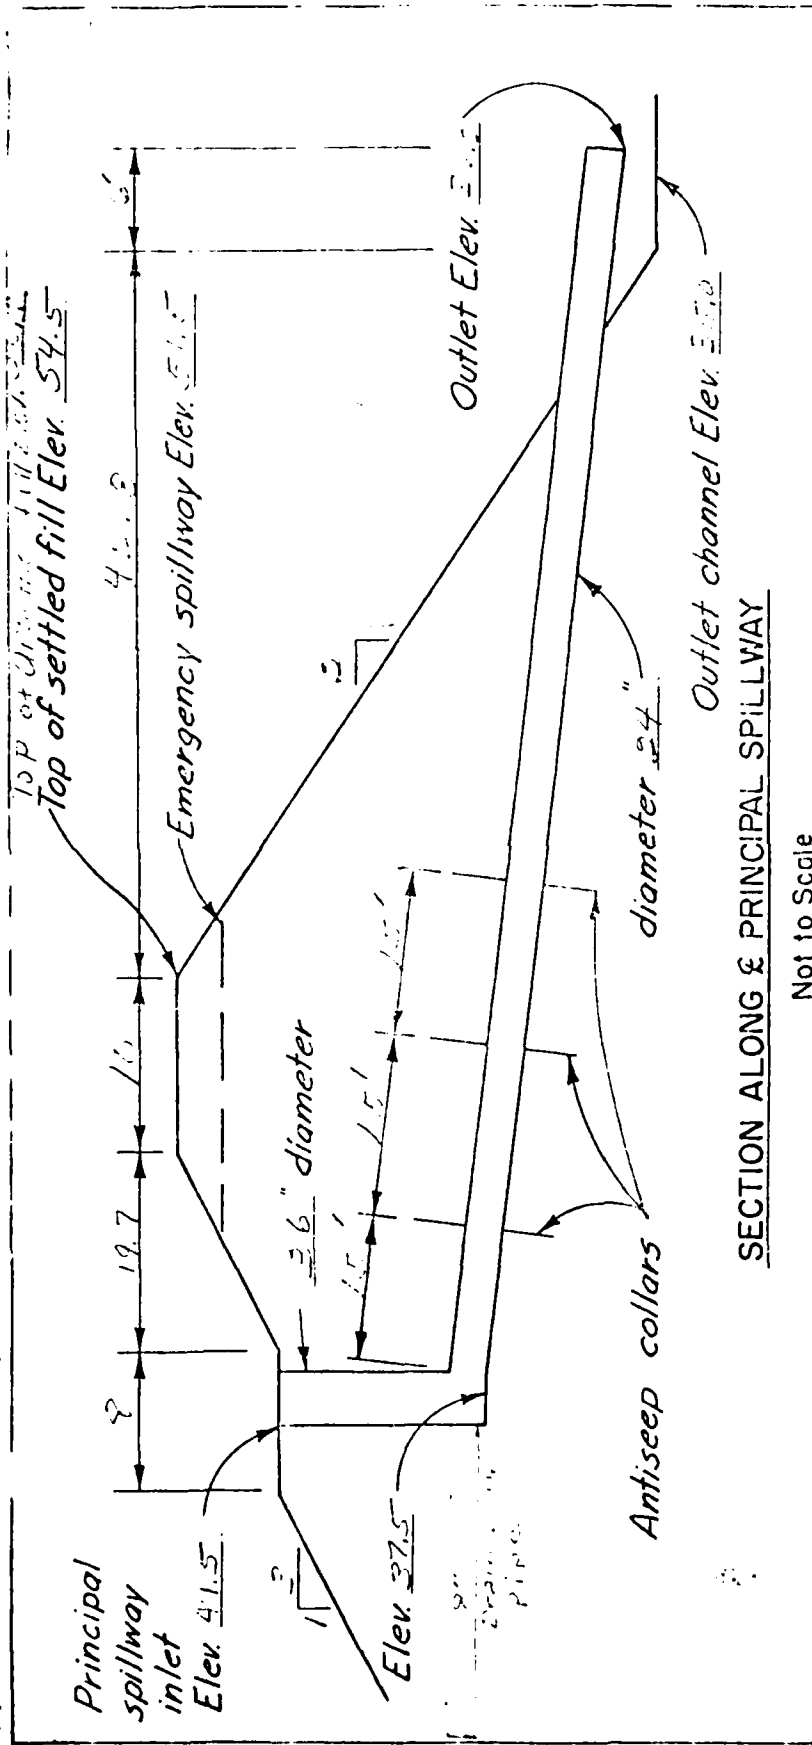
Sheet 4 of Appendix A

The Soil Conservation Service designed an embankment cross section which is shown on Sheet 4 of Appendix A. No other foundation or embankment design information was available. Information from the past owner, E. H. Green, indicates that the dam was constructed from the silty clay soils from the lake area. There is apparently no particular zoning of the embankment and no internal drainage features are known to exist. No construction inspection test results are available.
